A TALE OF TWO TOWERS: 450 WEST 33RD STREET

450 West 33rd Street – Façade Replacement

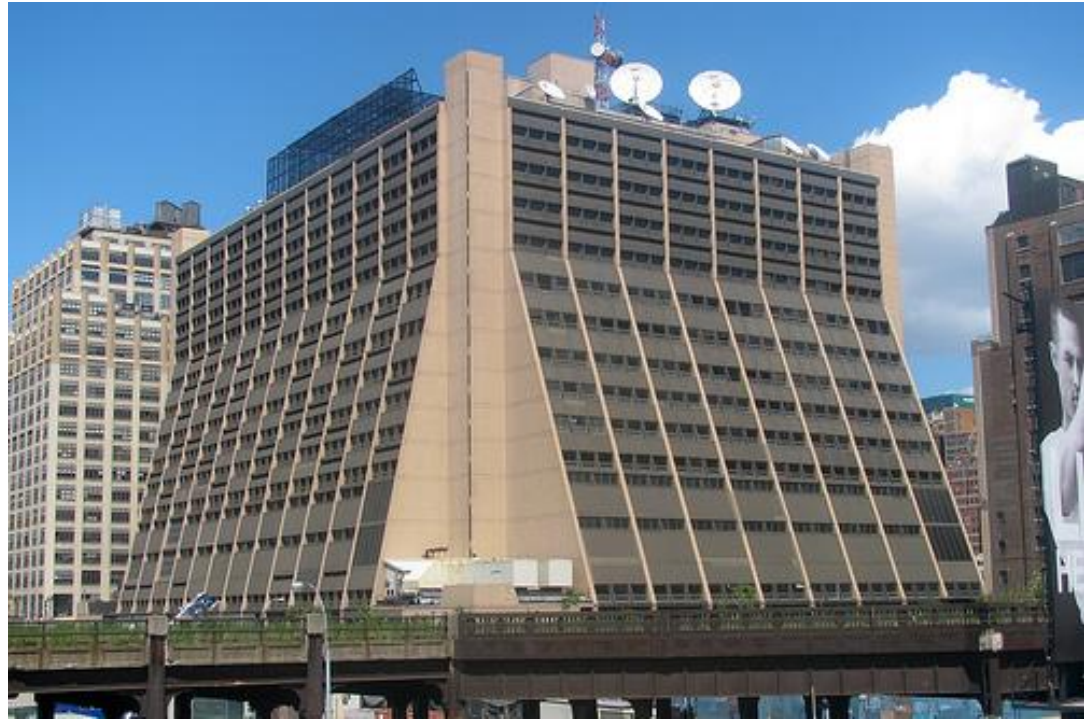
450 West 33rd Street – What Was Wrong?

1. Designed for warehouse space, converted to an office in late 1980's
2. Commonly labeled the “ugliest building in NYC”
3. 4 ft. high windows (less than 25% of wall space)
4. Too few elevators & only on 33rd Street
5. Dated Common Areas
6. Massive floor plates—average floor plate 120K sq. ft.
7. Rental rates when purchased in 2010 were high \$30s

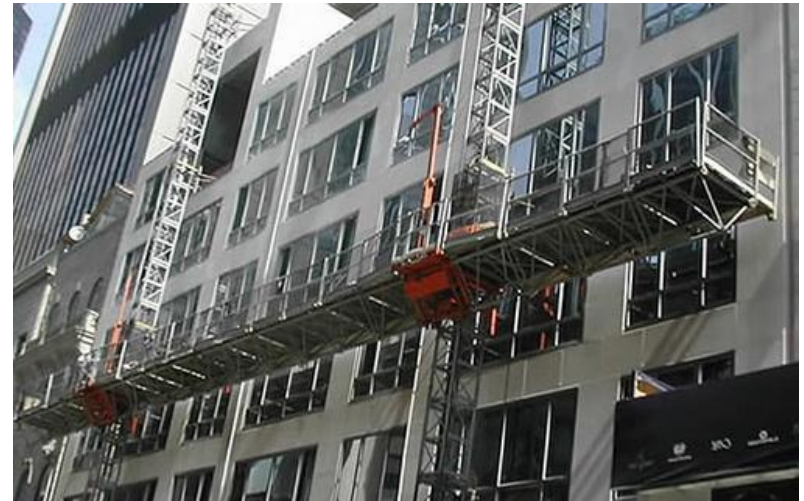
- After existing exterior façade removed, mass climber delivers new glass curtain wall to top of building and installs from top down
- As curtain wall installed, masts removed to the floor below to install next level of glass
- After curtain wall in place, temporary walls removed, office finishes restored, all is complete
